⑥ National Dam Inspection Program

HEILMAN DAM

(NDI NO. PA-00612,  
DER NO. 13-005)

PHASE I INSPECTION REPORT,

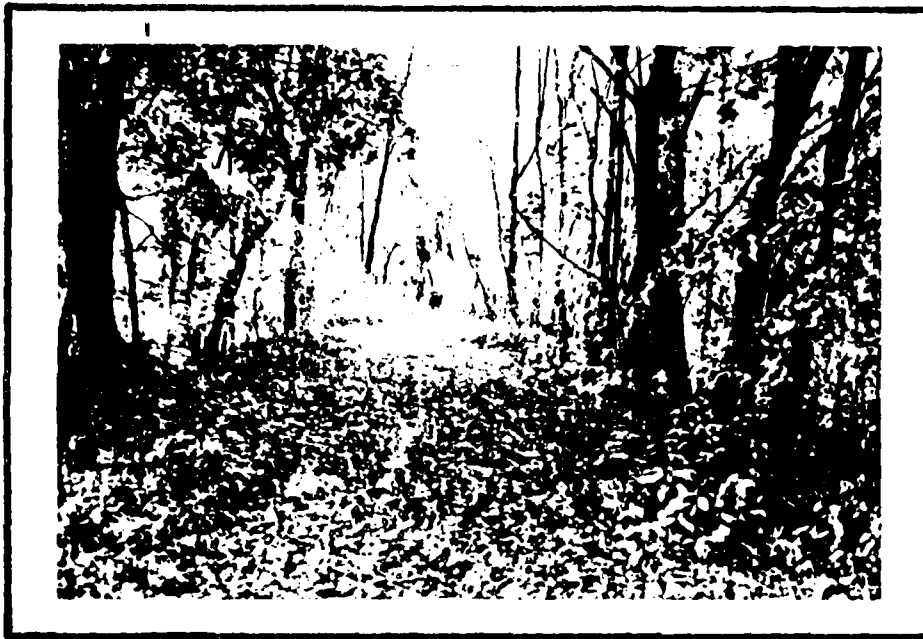
The embankment fills at each side of the spillway weir have not been maintained during the recent years. They are overgrown with trees and brush (Photographs No. 2 and No. 3). The embankment profile on Plate A-II, Appendix A, indicates that a considerable length of the embankment is below the design crest elevation, with deep erosions (up to 4 feet) adjacent to the spillway abutment walls. The downstream slopes at Sta. 0+30 are flatter than the design slopes. There were no signs of upstream slope protection.

LEFT EMBANKMENT FROM LEFT ABUTMENT - NO. 2

The overall visual evaluation of Heilman Dam indicates that the dam is in poor condition. It is recommended that all trees and brush be removed from the embankment. A protective cover should be provided on the embankment to prevent erosion.

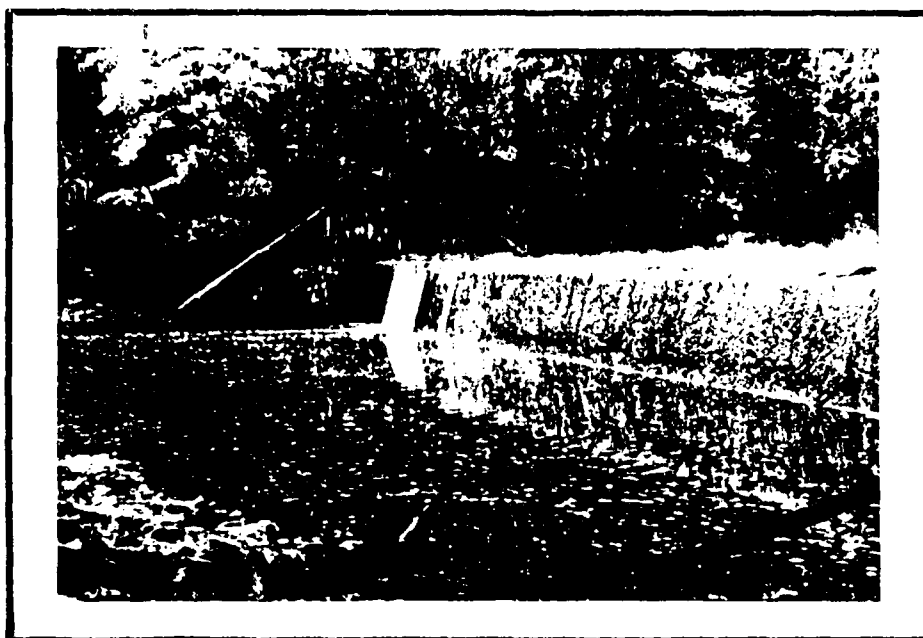
The spillway is located in the center of the dam and has a length of 125 feet. All inflow is discharged over the weir. The concrete of the weir has exposed aggregate, but there were no signs of cracks or structural instability. A constant flow over the weir and the downstream pool prevented close observation. Downstream from the weir is a submerged timber cribbing filled with stone.

The concrete weir is 66 years old and shows signs of deterioration. Aggregate has been exposed. However, there are no signs of structural instability. The drawdown sluice gate is not operable.

DOWNSTREAM FACE OF WEIR - NO. 4

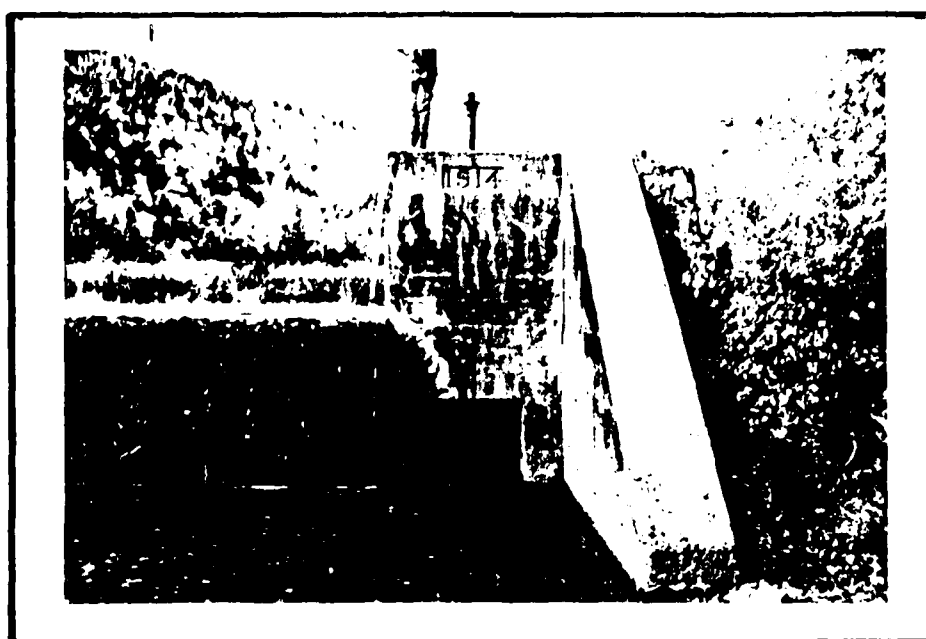
The weir has concrete abutments at each side. The left abutment contains a 4' x 4' opening, closed with a sliding gate. The gate stand and stem are broken and the gate is inoperable at the present time.

The only operating facility is a four foot sluice gate for drawdown. This gate is in the closed position, and is inoperable due to a broken stem and gate stand.

DOWNSTREAM SIDE OF OUTLET IN LEFT ABUTMENT WALL - NO. 5

3. That access above the floodplain be provided for surveillance.
4. That either a method be developed for opening the sluice gate in an emergency or the opening be permanently closed off.
5. That a formal surveillance and downstream warning system be developed for use during periods of high or prolonged rainfall.
6. That an operation and maintenance manual be prepared for guidance in the operation of the dam during normal and emergency conditions, and that a schedule be developed for the annual inspection of the dam and its appurtenant structures. The operational manual should include regular maintenance of the embankment.

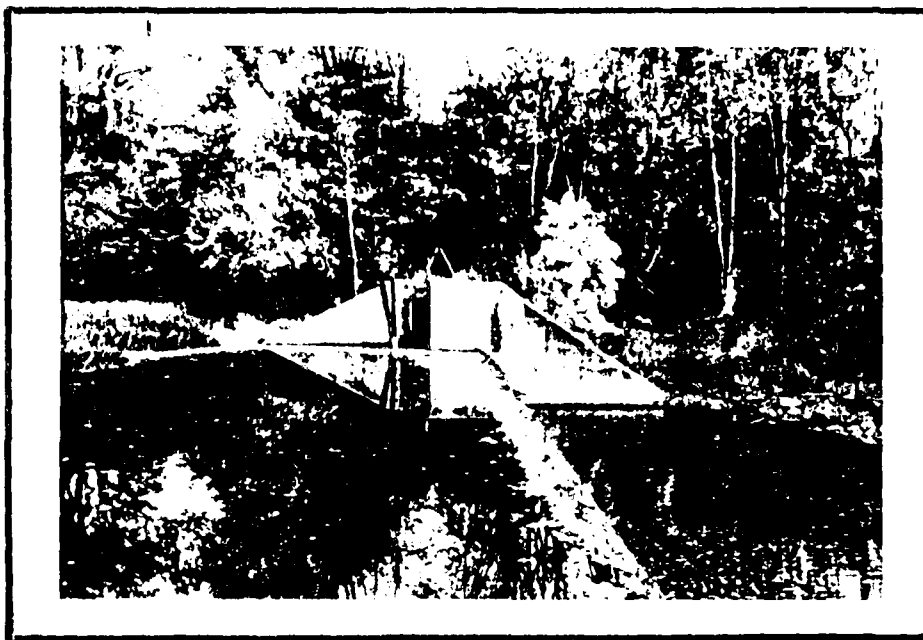
The dam appears to be in poor condition. Concrete spillway is weathered so that the aggregate is exposed over the entire visible surface. The embankment abutments with the concrete spillway are severely eroded. The embankment behind the spillway walls is about 4 feet below the top of the wall.

LEFT SIDE OF SPILLWAY AND ABUTMENT - NO. 6
